## **Final Report: Nano Paint**

New Mobility Strategic Planning and Policy TransLink

## **Executive Summary**

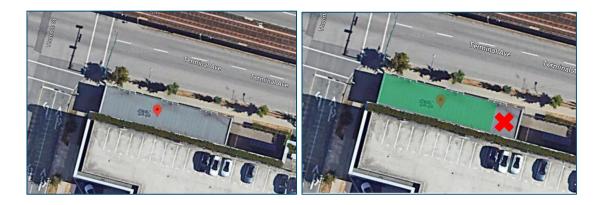
The first phase was tested in BCRTC's substation located at the corner of Thornton Street and terminal avenue in Vancouver, BC.

Roof Material: 2-ply SBS with granulated surface Roof measurement: approximately 2,175 sq. ft. Address: 540 Terminal Avenue Vancouver, BC Gallons used: 12 gallons (CAD 517/gallon) Cost per square ft: \$2.85

The effectiveness of the paint was demonstrated using comparative temperature data of a surface that is covered by the Nano coating and a surface that is not. 80% of the building was covered with nano paint and the remaining 20% was left unpainted. This allowed a direct comparison to be made between the portion treated with the Nano material and untreated, under identical conditions.

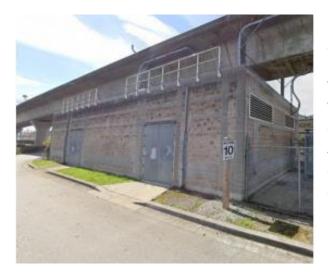
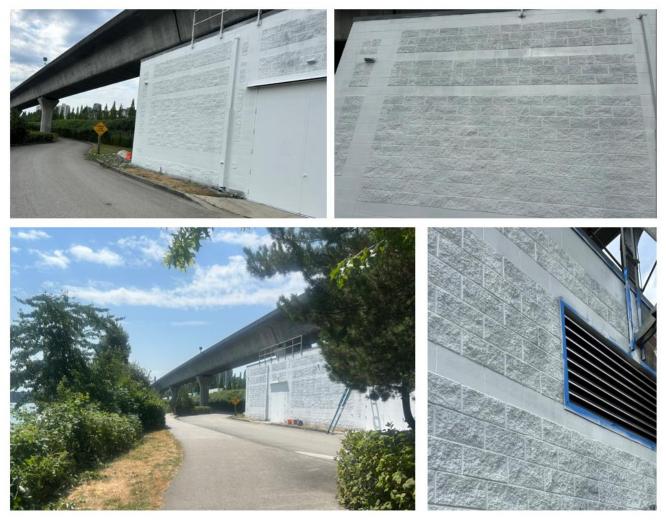
Figure 2: After nano paint application

For this phase, the team identified an infrastructure that has sun exposure to test during the summer. The building that was selected is a substation under the Skytrain with no adjacent buildings beside. The location is in the Brunette-Fraser Regional Greenway in New Westminster between Sapperton and Columbia station.

Roof Material: 2-ply SBS with granulated surface Roof measurement: approximately 2,580 sq. ft. Wall Material: Clay Sediment (Brick) Wall Measurement: 3,944 sq. ft. Geographic coordinates: 49.2200650°N, 122.8923881°W Gallons used: 35 gallons (CAD 265/gallon) Cost per square ft: \$1.41 Thermometers were installed inside and outside of the building. Temperature was tracked on an hourly basis before and after the paint was applied to measure effectiveness of the paint in cooling the interior of the building.

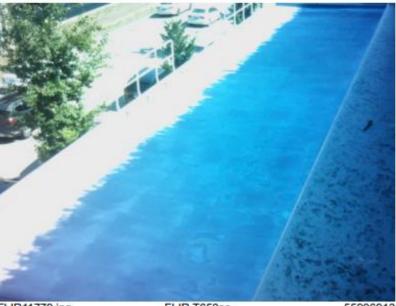
The Second Images were taken at 12:57 pm with an exterior Temperature of 26.3 degrees Celsius with 47.3% RH. The final coats were applied prior to the temperature scanning. The Rooftop area had some surface moisture at the time of scanning.

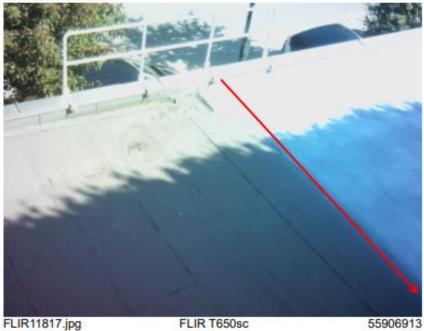
Figure 6: 3rd Reading

The read arrow is highlighting the divided area where the paint is applied and not applied to the roof surface.

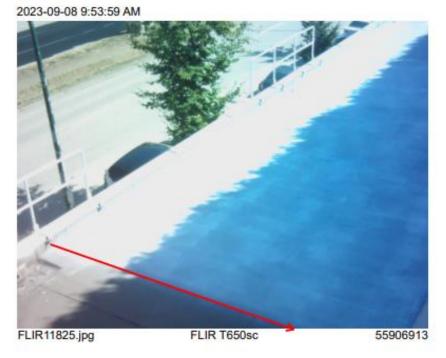
Figure 7: 3rd Reading

The read arrow is highlighting the divided area where the paint is applied and not applied to the roof surface.

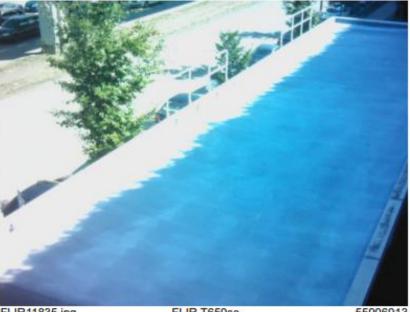
The fourth Images were taken at 12:01 pm with an exterior Temperature of 24.2 degrees Celsius with 52.2% RH.

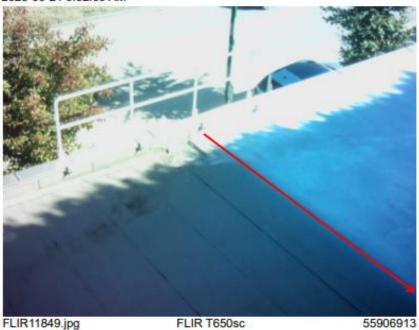
Figure 9: 5th Reading

The read arrow is highlighting the divided area where the paint is applied and not applied to the roof surface.
