## Memorandum

**Project:** 1418.04 Burnaby Mountain Gondola

**Subject** Gondola System Vandalism

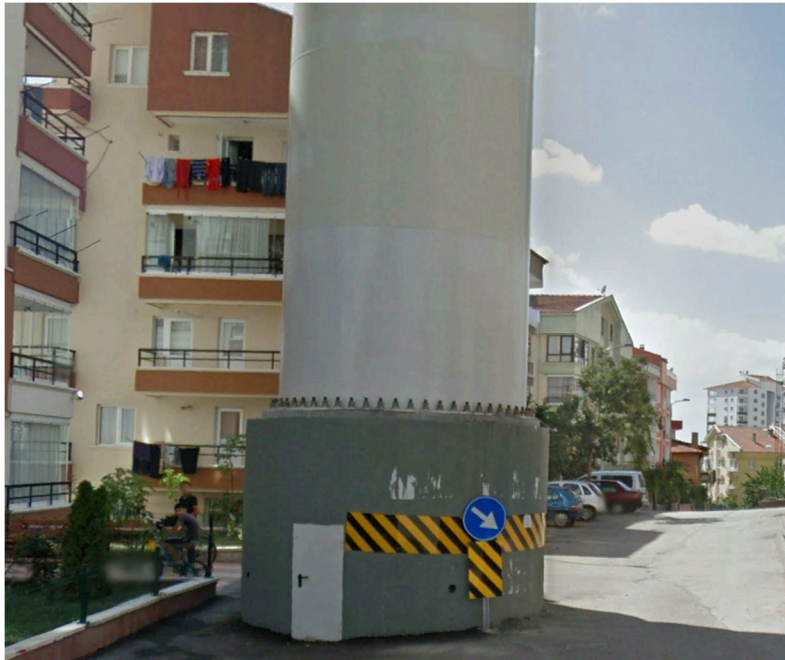
- Finally, stations and towers should be designed in a way that eliminates the possibility of unauthorized persons accessing critical system components, specifically the system's cables. Stations are buildings and typical barriers to entry and security systems are adequate to protect the system's cables. With regards to towers, rather than constructing lattice-type towers similar to power transmission towers, unclimbable tubular towers can be installed. Additionally, instead of placing maintenance ladders on the exterior of towers, ladders can be placed on the inside as is done with wind turbine towers. In this configuration, tower access would be controlled by lockable doors and monitored with a security system. A similar arrangement was implemented on an urban cable car system in Ankara, Turkey.
